Manhole Inspection Summary

Manhole # S29GG2010MH

Insp Date: **1/4/07 11:26 AM**

Location Address: **5719 CHARLES ST**

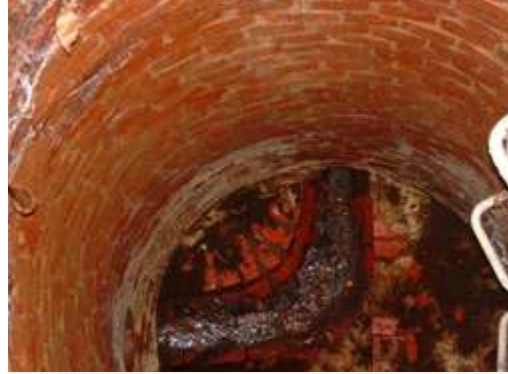
Top View

Evidence of surcharge - Bench debris.
Bench root intrusion. Channel debris.

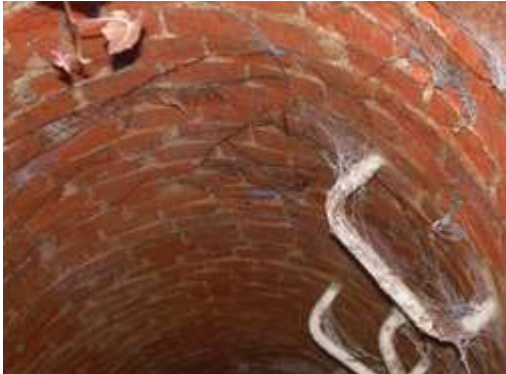
Defect

Adjustment and Corbel root intrusion and infiltration - other side.

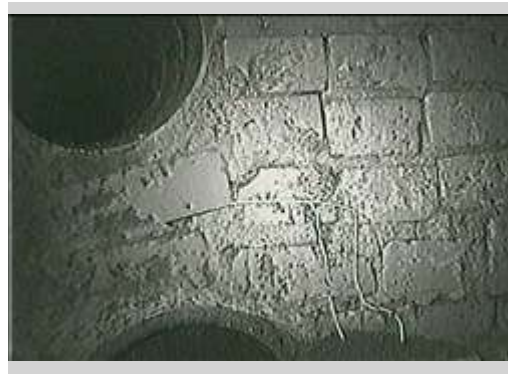
Defect

Barrel root intrusion.

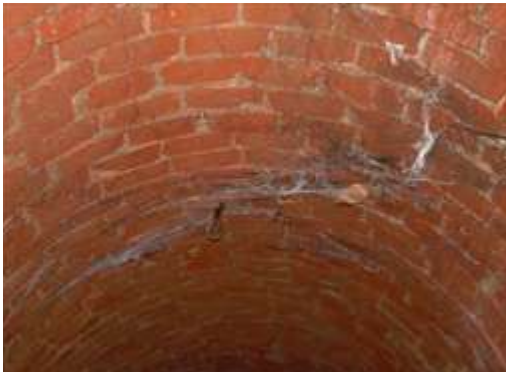
Defect

Adjustment and Corbel root intrusion and infiltration.

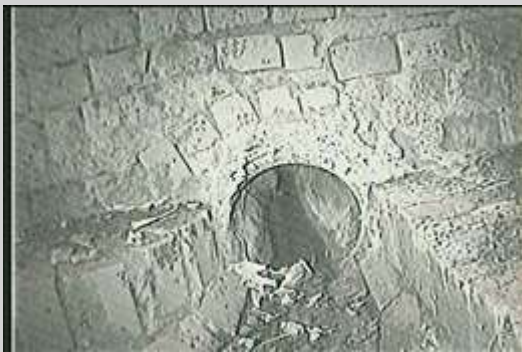
8 in. Circular Gravity Sewer Pipe Out @ 12 O'Clock

Deposits: ☐ None ☐ Mud ☐ Sludge ☒ Debris ☒ Grease

Infiltration: **Evidence** Pipe Seal Cond: **Roots**

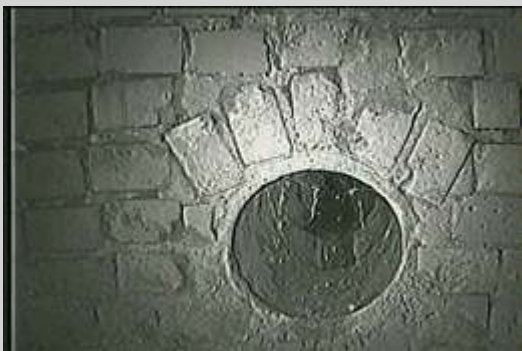
8 in. Circular Gravity Sewer Pipe In @ 9 O'Clock

Infiltration: **Evidence** Pipe Seal Cond: **Roots**

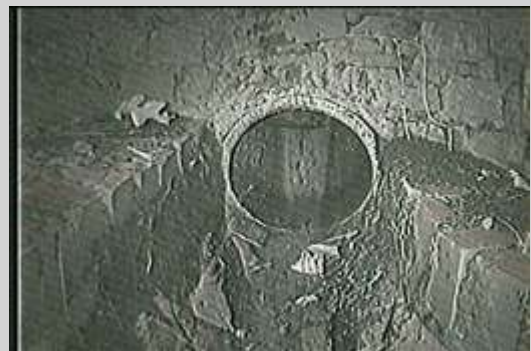
Drop In @ 9 O'Clock

Barrel deterioration and infiltration. Channel root intrusion.
